# Evaluation of unilateral condyle head fracture on panoramic and CBCT imaging: a case report

Meiryndra Syaira Putri<sup>1\*</sup>, Belly Sam<sup>2</sup>, Lusi Epsilawati<sup>2</sup>

**Objectives:** This case report aimed to describe the radiographic characteristics of the fracture of the condyle's head and its impact on surrounding tissues in a young adult patient using panoramic and CBCT radiographs.

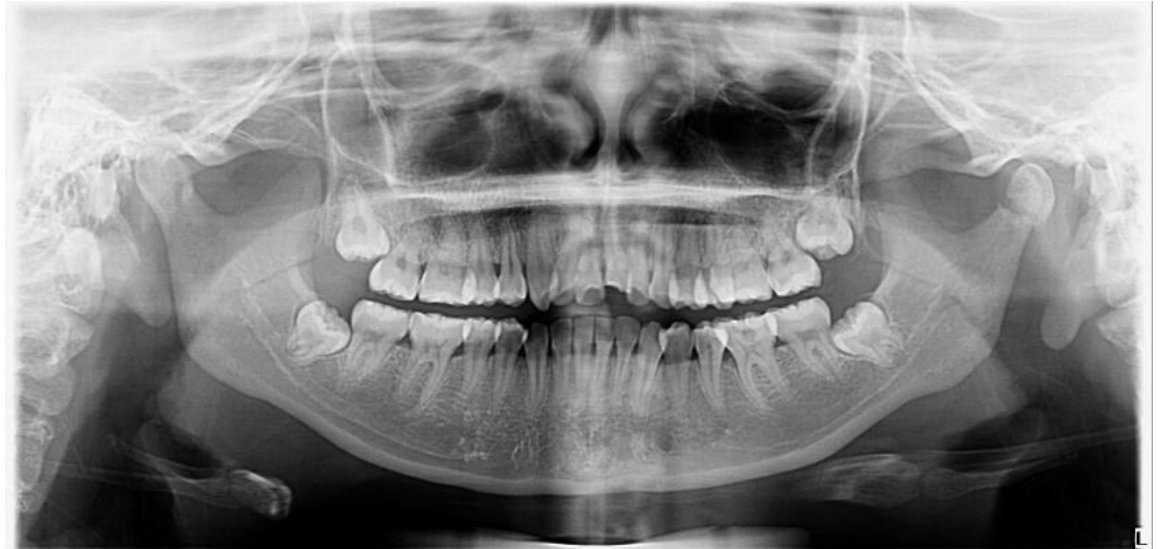
**Figure 6.** Orthopantomogram/panoramic Imaging showed a radiolucent line (fracture-like) on the left-side condylar.

At the first visit, the patient took an orthopantomogram/panoramic examination (Figure 6), which showed the results of a fracture in the head of the left condyle. The results of the panoramic examination showed that the fracture of

the crown of tooth 21 reached the depth of the pulp. The image of the condyle head showed a partial non-fragmented fracture line with horizontal medial displacement, and there was a medial displacement of the condyle head. On the second visit (May 28, 2024), the patient took CBCT photos for further examination, with the results of the CBCT examination showing coronal, sagittal, and axial views of the sinistra condyle (Figure 7). The coronal view of the sinistra condyle showed a fracture of the condyle neck (Figure 8). The anteroposteriorly transverse condyle fracture fragment was  $\pm 11.8$  mm in length. The fracture fragments were irregular with a size of  $\pm 18.4$  mm (mediolateral) x  $\pm 13.4$  mm (superoinferior). The sagittal view of the sinistra condyle shows a fracture of the condyle neck where the fracture fragments are on the medial side of the condyle neck (Figure 9). The position of the condyle is posterior to the glenoid fossa and located in the eminence fossa. The distance from the condyle head to the fossa eminence is  $\pm 3.6$  mm. The sagittal view of the sinistra condyle shows a fracture line of
